FI Missouri Remediation Trust

Re: Administrative Settlement and Order on Consent for Treatability Study ("TS"), Docket No. CERCLA -07-2016-0004 (the "Settlement")
FI Missouri Remediation Trust Property, Joplin, Missouri

Photographic Documentation

RE: Construction Summary Report
Lateral Drain System
Former Farmland Industries Site
Joplin, Missouri

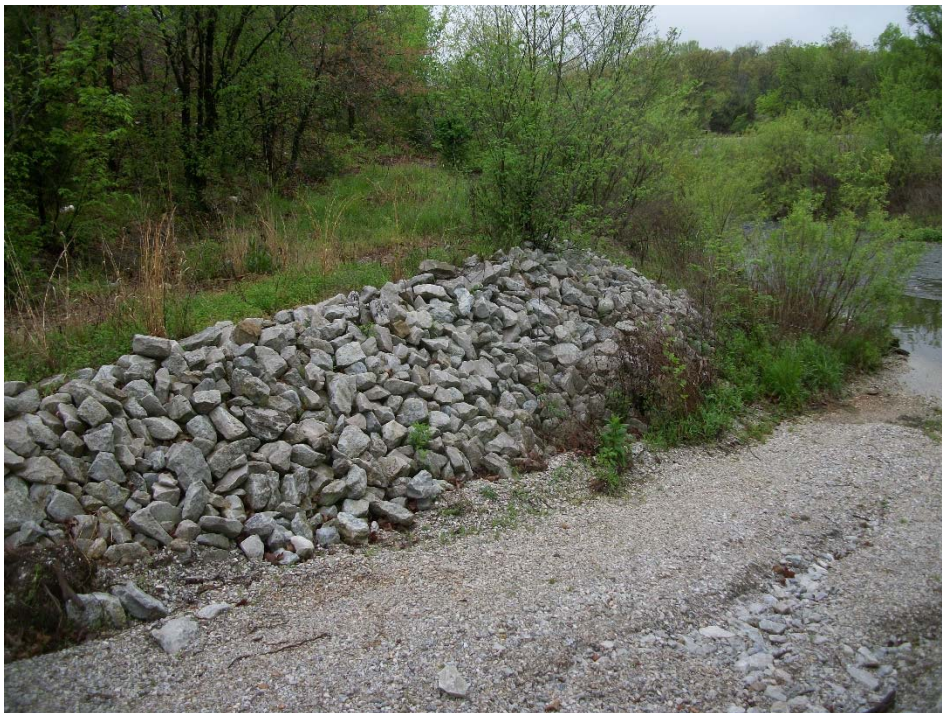
Description: Photo 1
Pre-construction
North End of Trench near
Short Creek

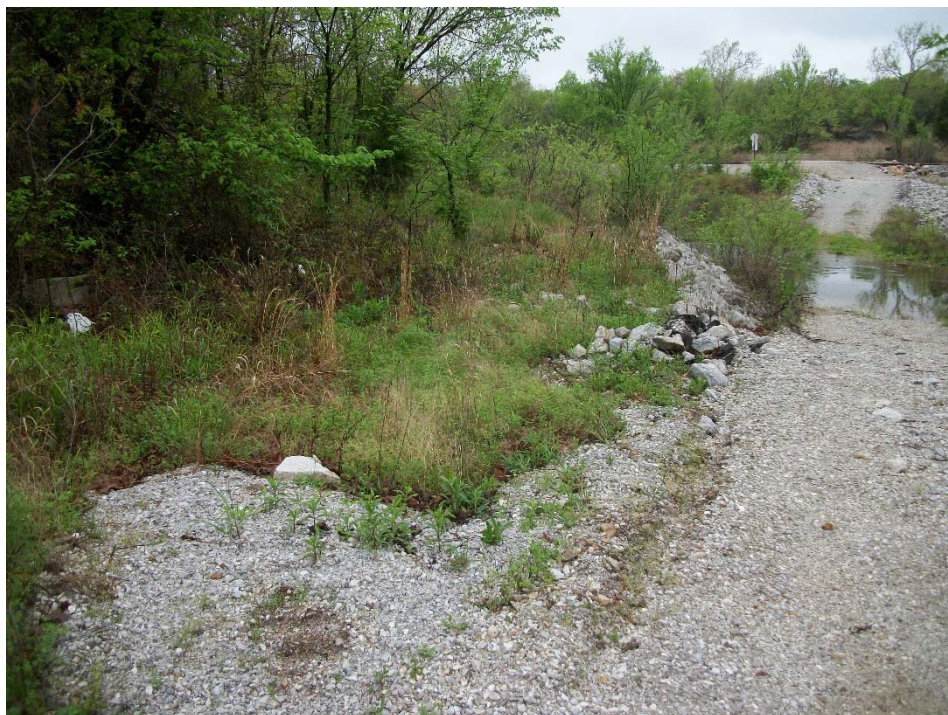
Description: Photo 2
Pre-Construction
North Trench

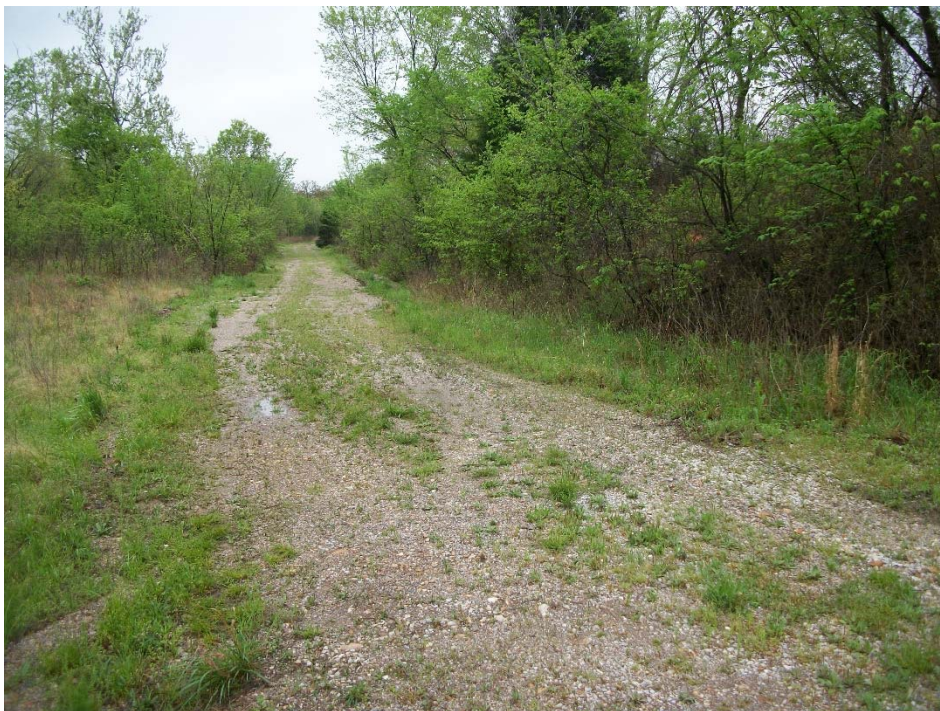
Description: Photo 3
Pre-construction Trench

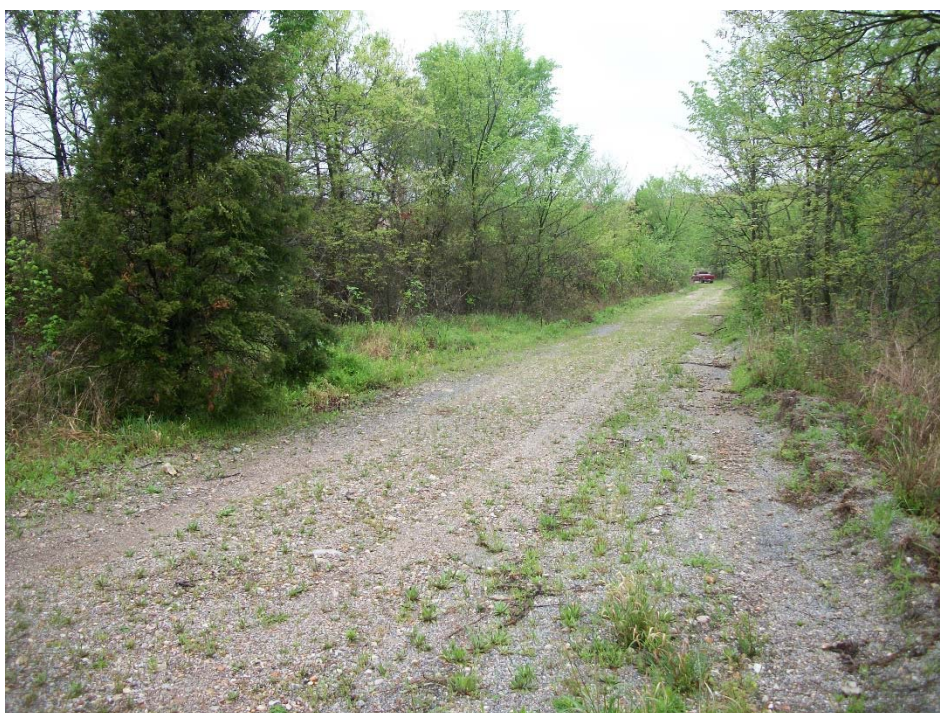
Description: Photo 4
Pre-construction Trench

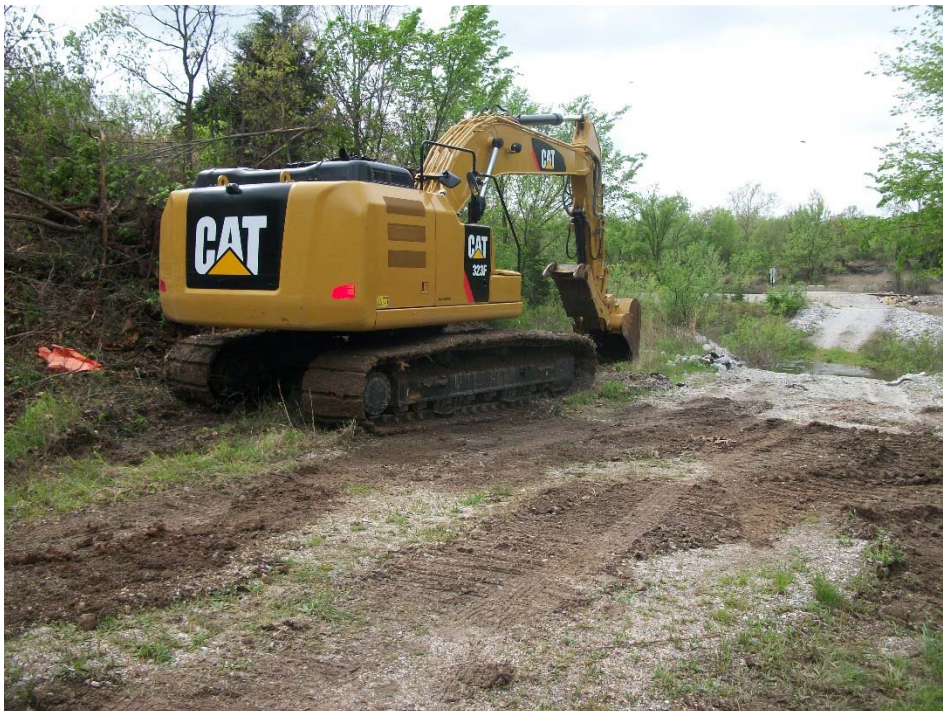
Description: Photo 5
North Trench –
Began Excavating
Direction: South

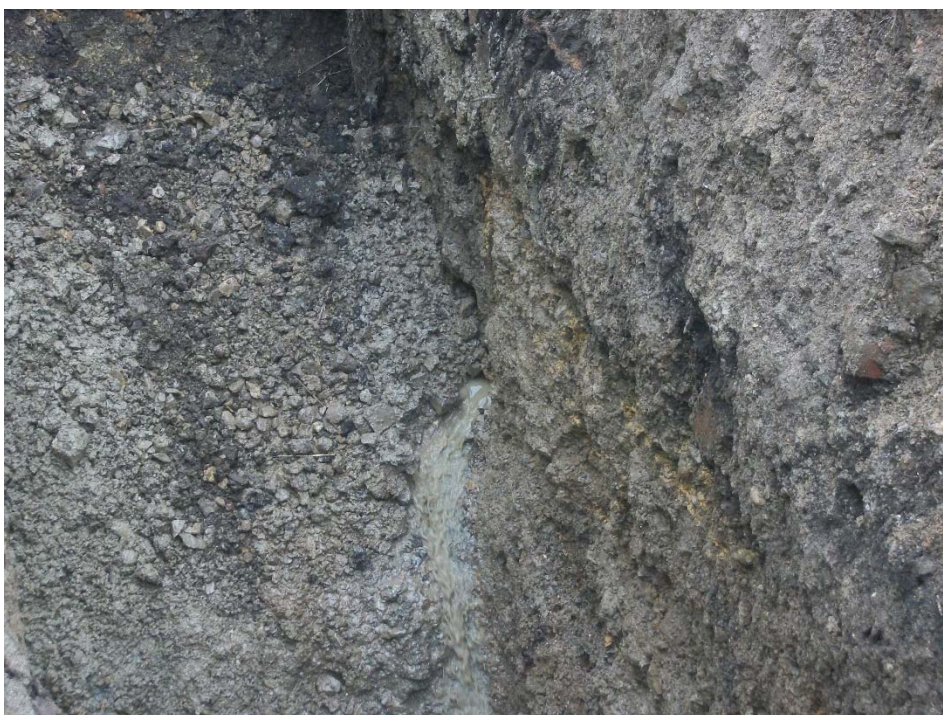
Description: Photo 6
North Trench – Seep
Direction: Southwest

Excavated from STA 3+53 to 4+04, Photograph 5. A high volume of water, estimated at approximately 80 gpm, entered the excavation at STA 3+53, Photographs 6 and 7. The north excavation was discontinued until the MDNR and/or EPA project managers could be notified of high inflow condition to review options.

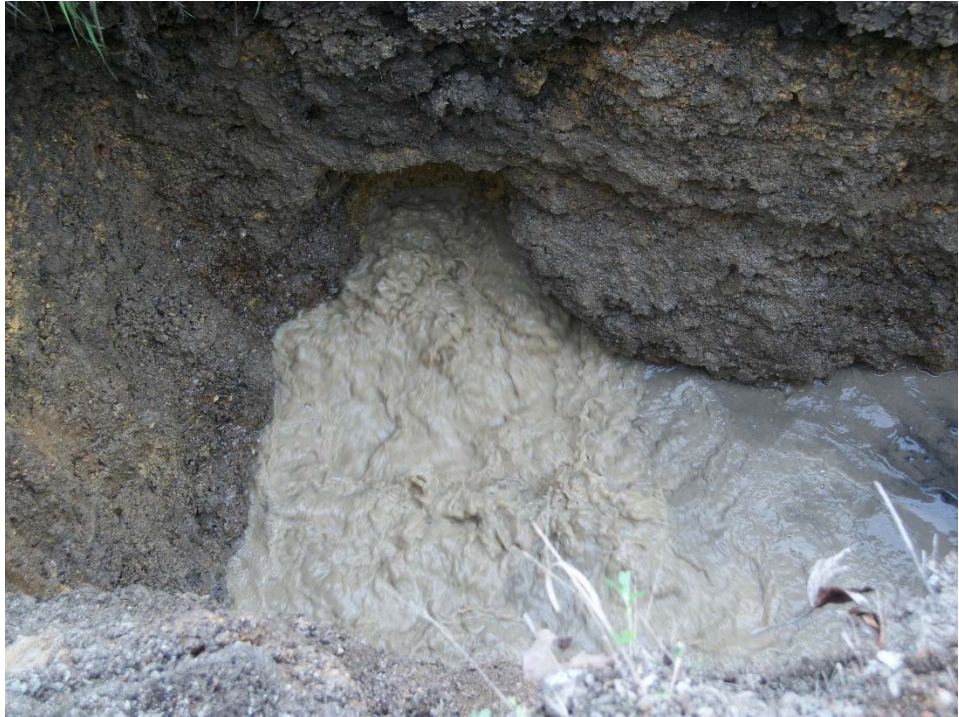
Description: Photo 7
North Trench - Inflow

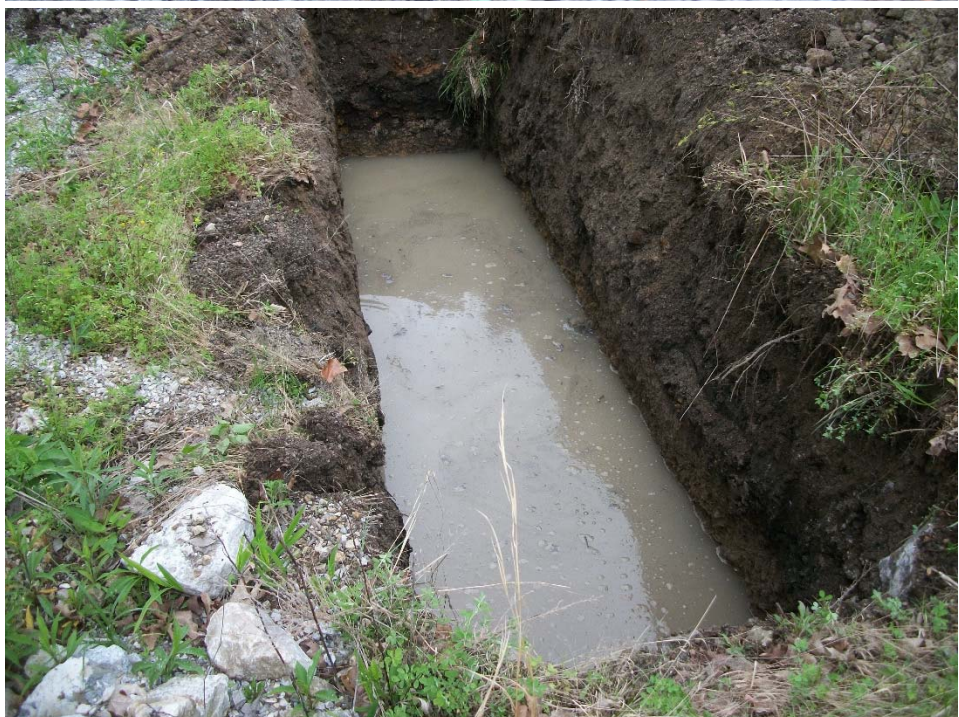
Description: Photo 8
North Trench - Full

At approximately 1630, water was encountered in the excavation near STA 3+53. At 1645, the water level in the north excavation rose to 4 feet bgs, Photograph 8. The trench was allowed to fill overnight to determine the static water level.

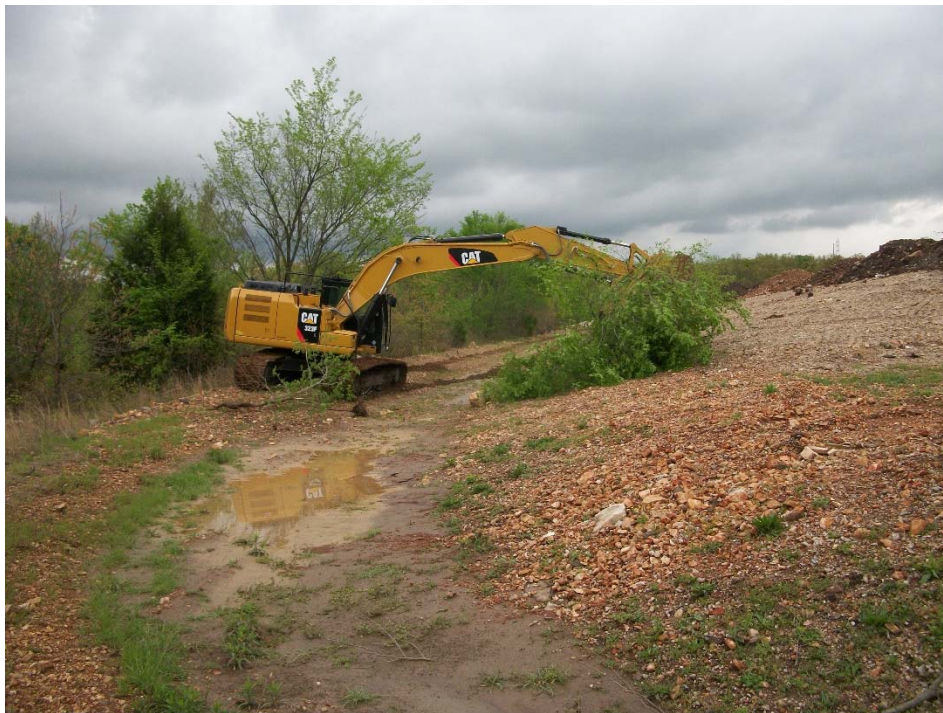
Description: Photo 9
Tree Removal

Trees and woody vegetation were cleared along the west side of the access road from Short Creek to gypstack letdown structure, approximately 450 feet. The vegetation was placed on top of the gypstack for consolidation. Preconstruction conditions are documented in Photographs 1 through 4. Tree removal is documented in Photograph 9.

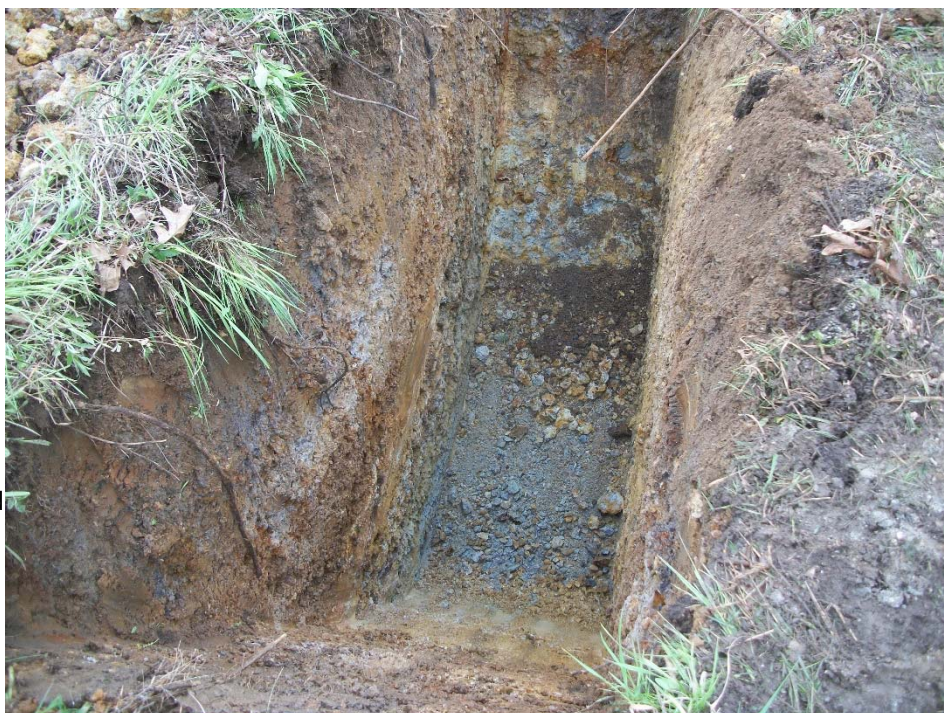
Description: Photo 10
South Trench – Weathered
Shale/Chert

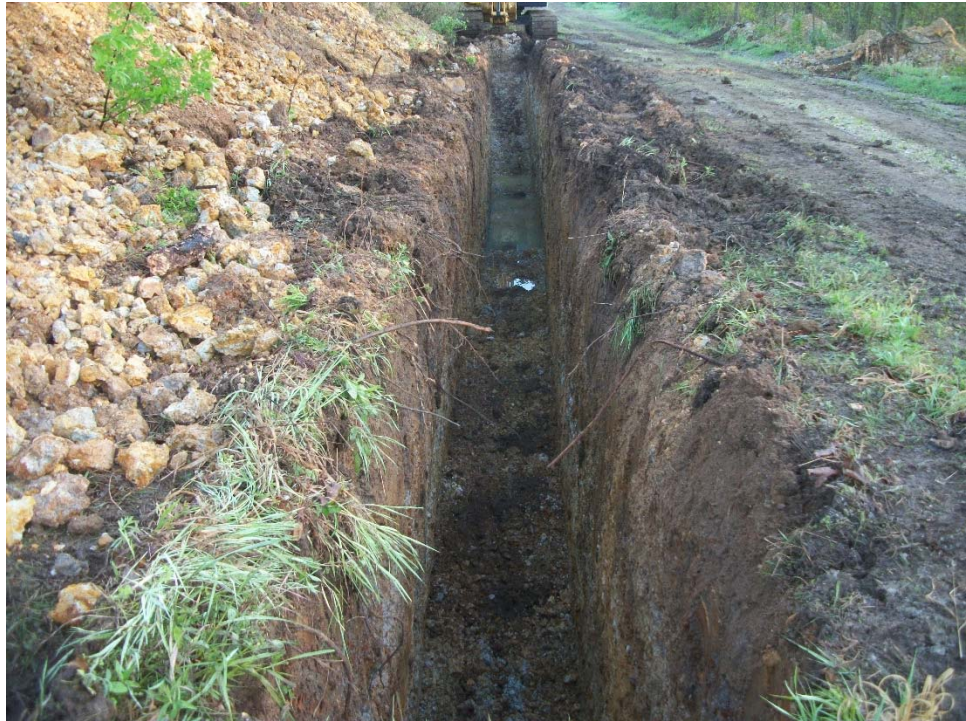
Description: Photo 11
South Trench

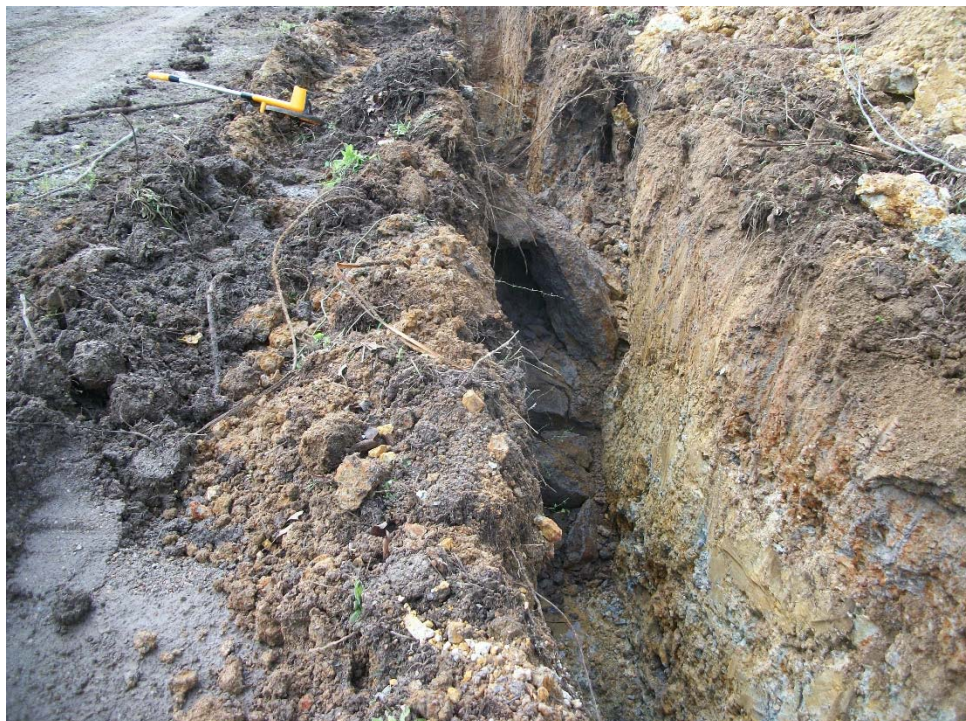
Description: Photo 12
South Trench Collapse

Excavated from STA 0+00 to 0+80. The average depth of the trench was 10 feet bgs. Hard excavating at depth due to tightly compacted chert gravel and boulders in a weathered shale matrix, Photograph 12. Encountered weathered limestone bedrock at 8 feet bgs near STA 0+80. No measureable quantities of water were observed.

Excavated trench from STA 0+80 to 2+30, Photograph 10 and 11. The west bank of trench collapsed from STA 0+13 to 0+35 while excavating at STA 1+17, Photograph 12. The lower portion of the trench consisted of chert boulders in a weathered shale matrix. Water entered the trench near STA 1+86 at 7 feet bgs along a rock ledge.

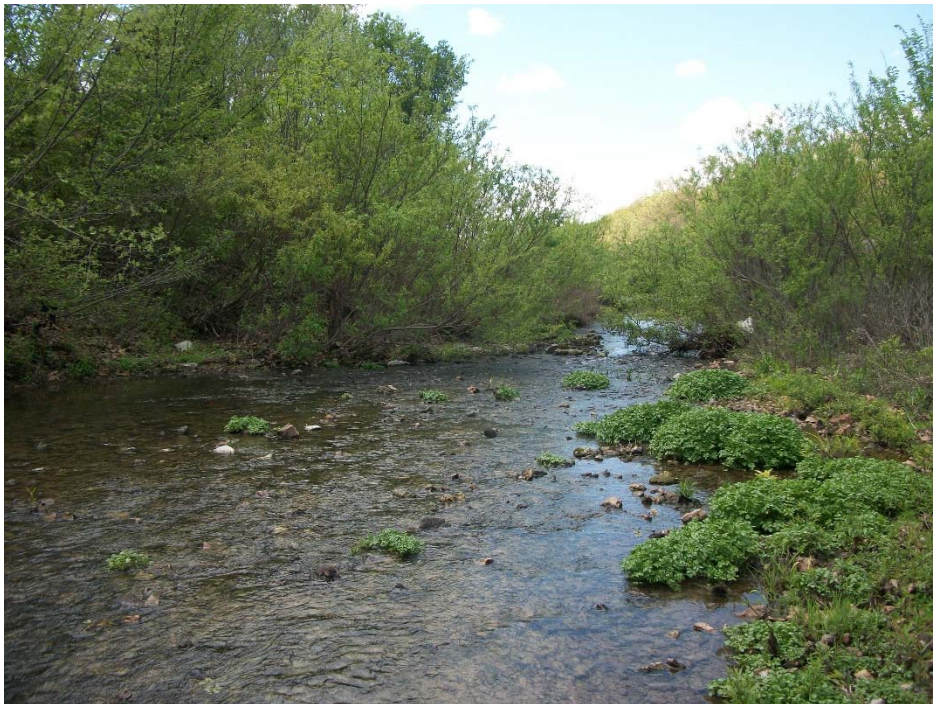
Description: Photo 13
Short Creek – Before
Cleanout

Preclearing conditions are documented in Photographs 13 and 14. High flow conditions following the creek clearing are documented in Photograph 33.

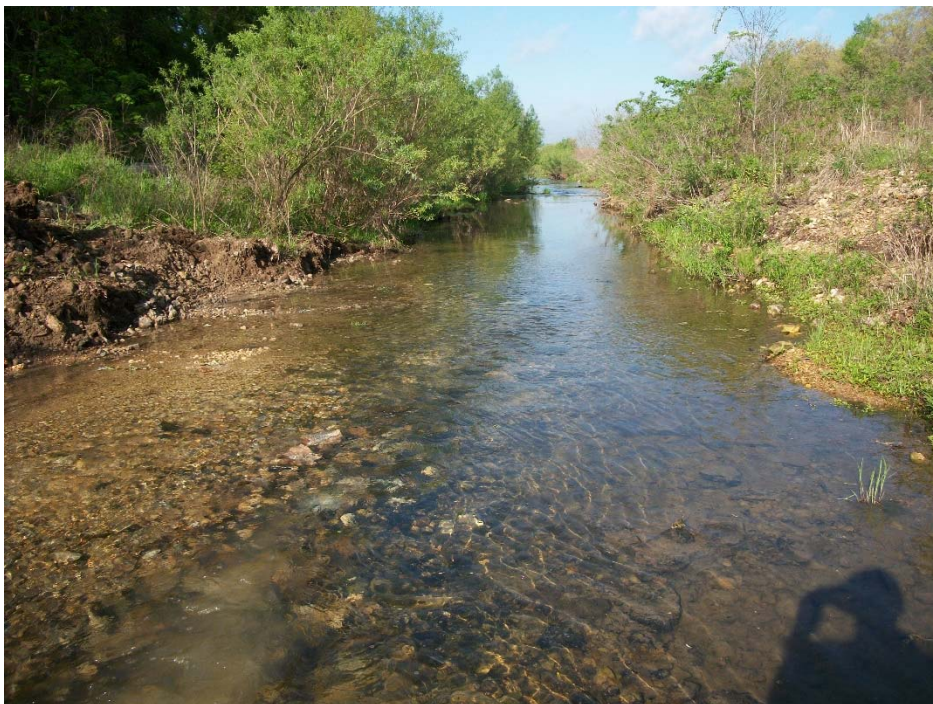
Description: Photo 14
Short Creek - After
Cleanout

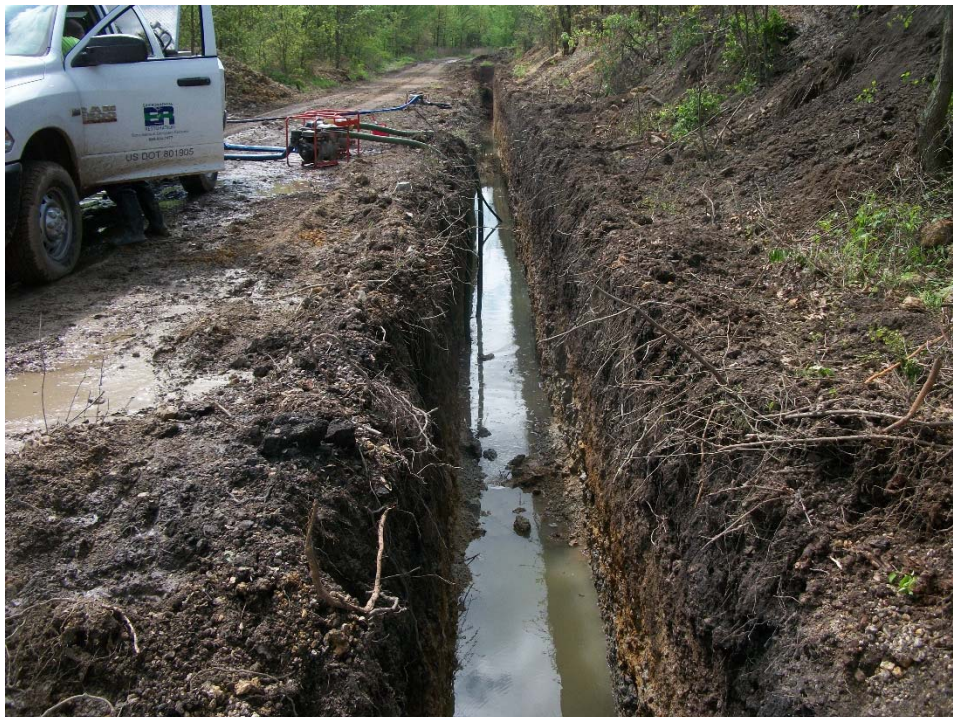
Description: Photo 15
South Trench – Water
Management

At 1537, began dewatering near STA 1+20 using a 2-inch pump discharging water at approximately 80 gpm and near STA 1+60 using a 3-inch pump, Photographs 15 and 16.

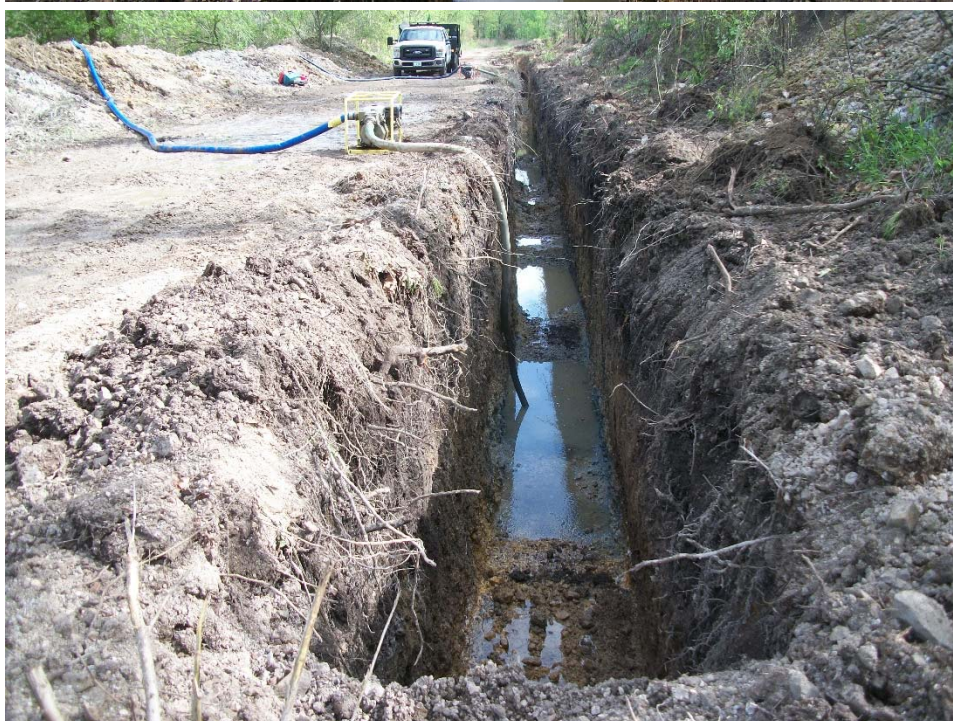
Description: Photo 16
South Trench - Water
Management

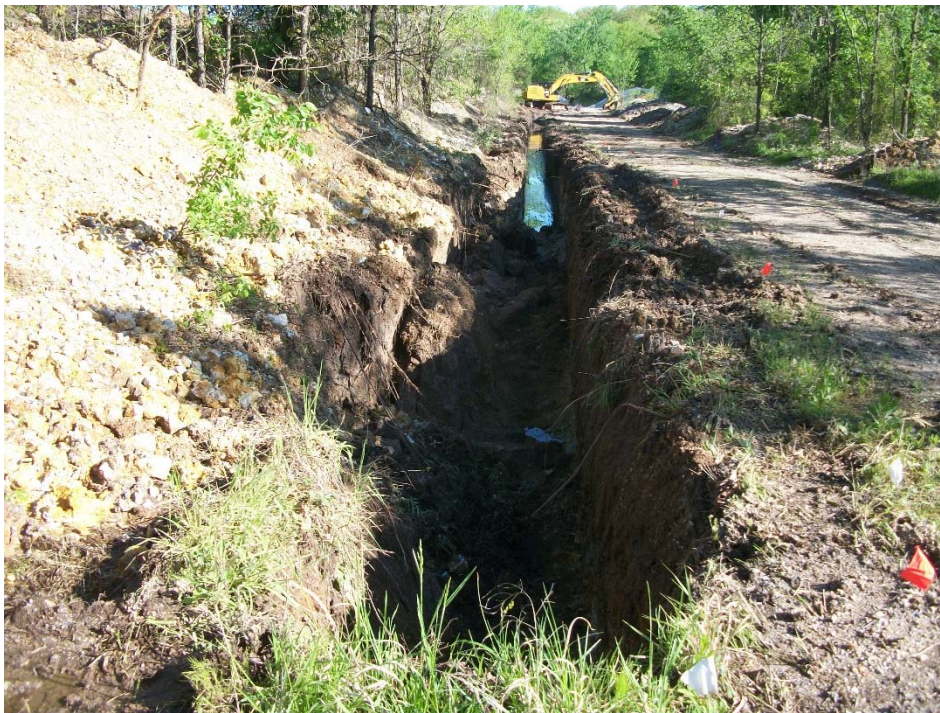
Description: Photo 17
South Trench – April 24,
2017 (Collapse)

Arrived on site at 0900 to resume trench excavation activities. Heavy rains over the weekend resulted in damage to the south ramp of the creek crossing and the collapse of the south side of the trench from STA 0+03 to 0+70. Photographs 17 through 20.

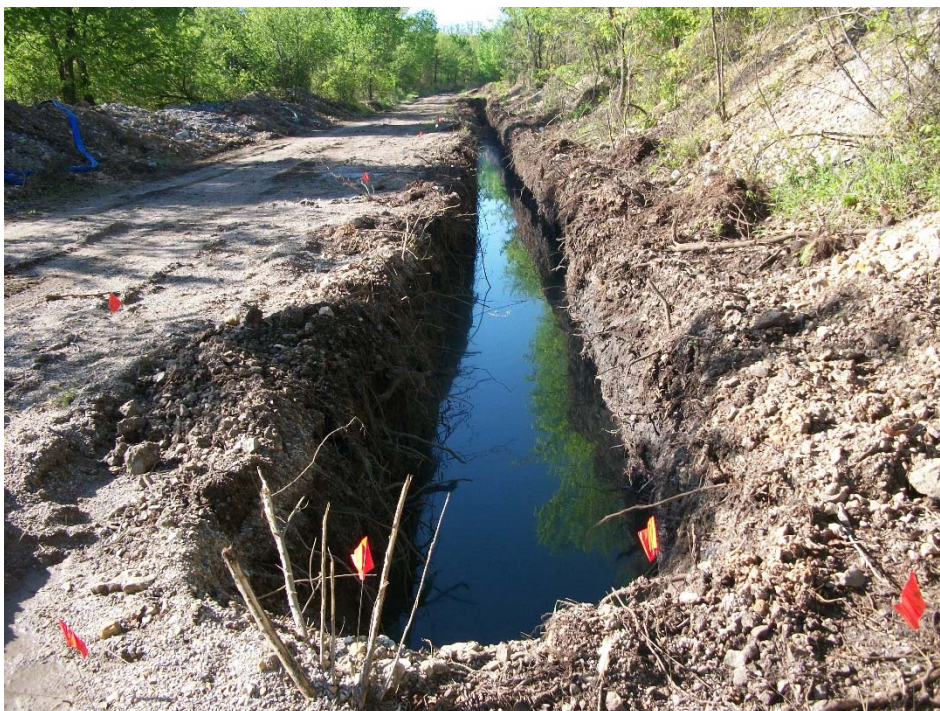
Description: Photo 18
South Trench - April 24,
2017

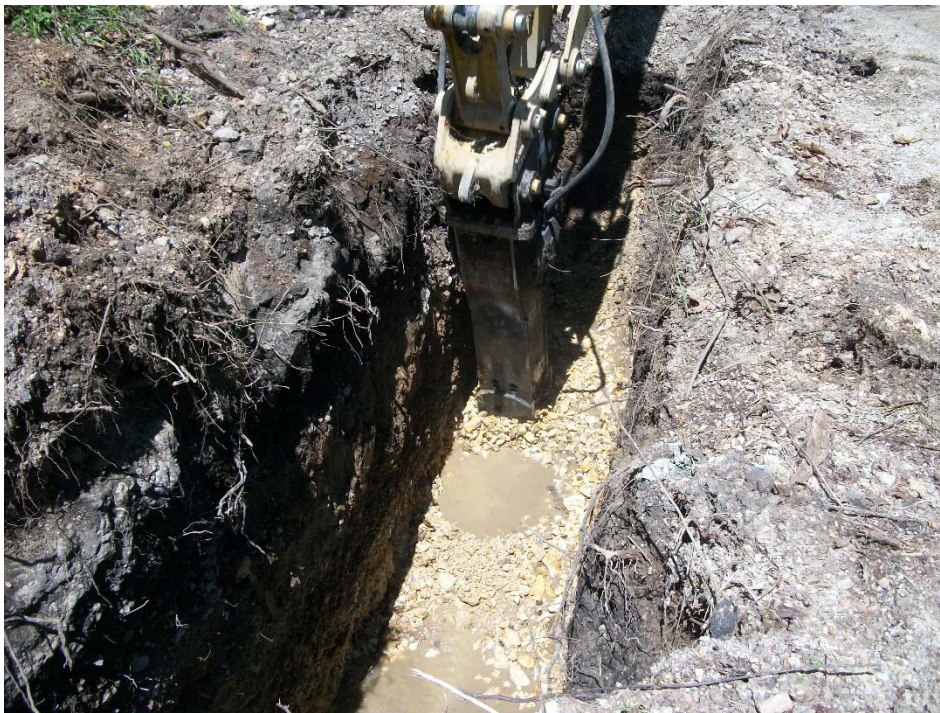
Description: Photo 19
South Trench – Rock
Hammer

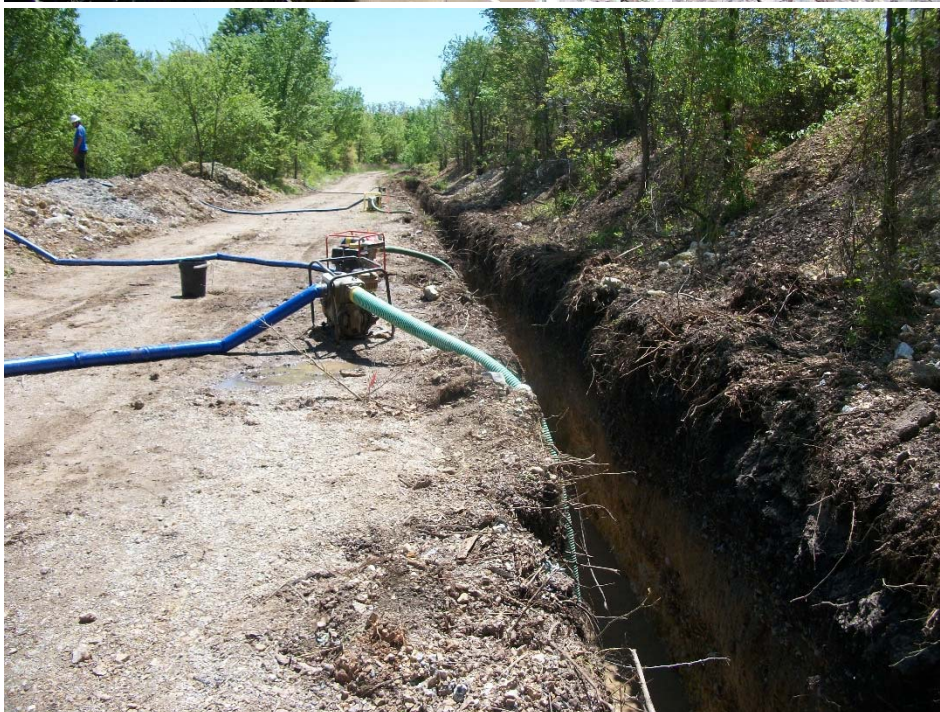
Description: Photo 20
South Creek – Water
Management

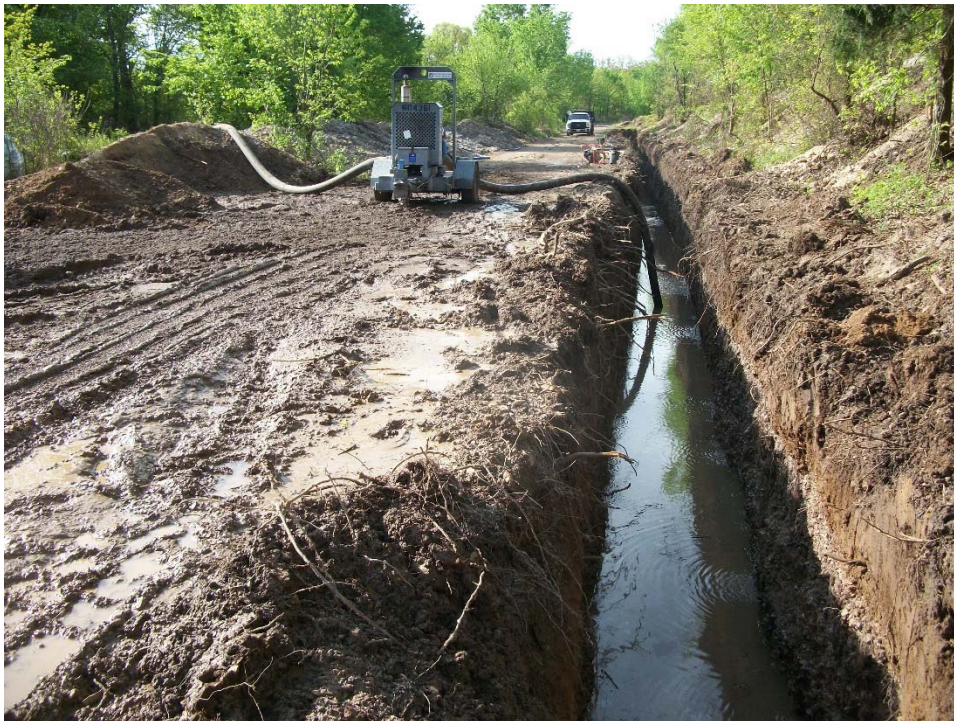
Description: Photo 21
South Trench – Water
Management, 6-inch
Pump, seeps

Excavated from STA 3+17 to 3+45. Multiple inflows observed along trench wall, Photograph 21. Very hard excavating due to limestone bedrock, Photograph 22. Encountered high inflow of water at STA 3+45, discharge approximately 80 to 100 gpm, Photographs 23, 24, 27, and 28.

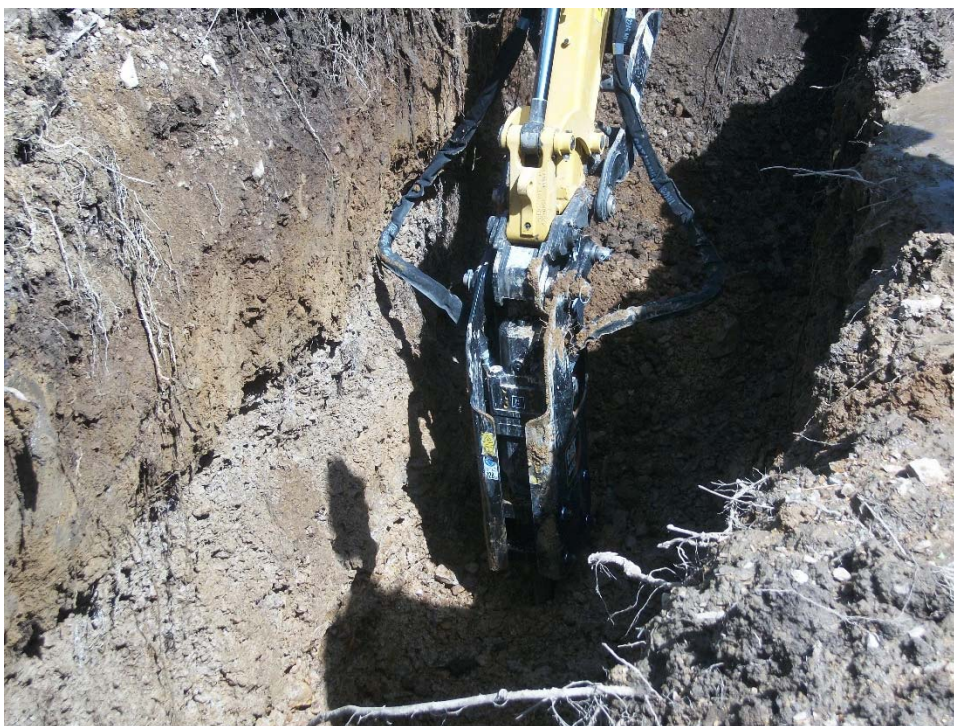
Description: Photo 22
South Trench – Rock
Hammer

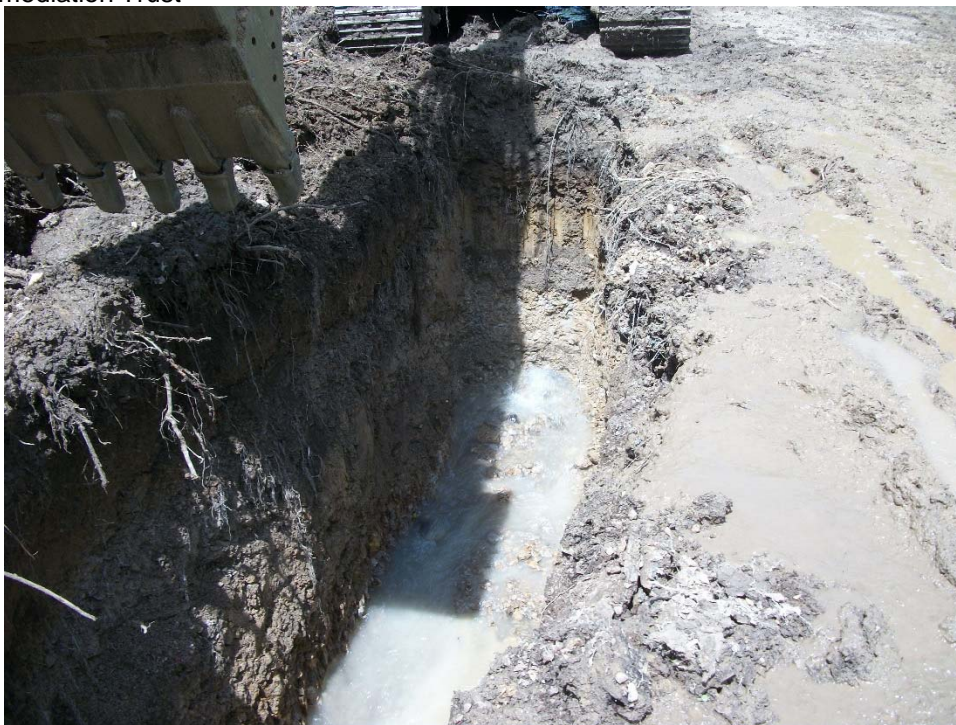
Description: Photo 23
South Trench – High
Inflow

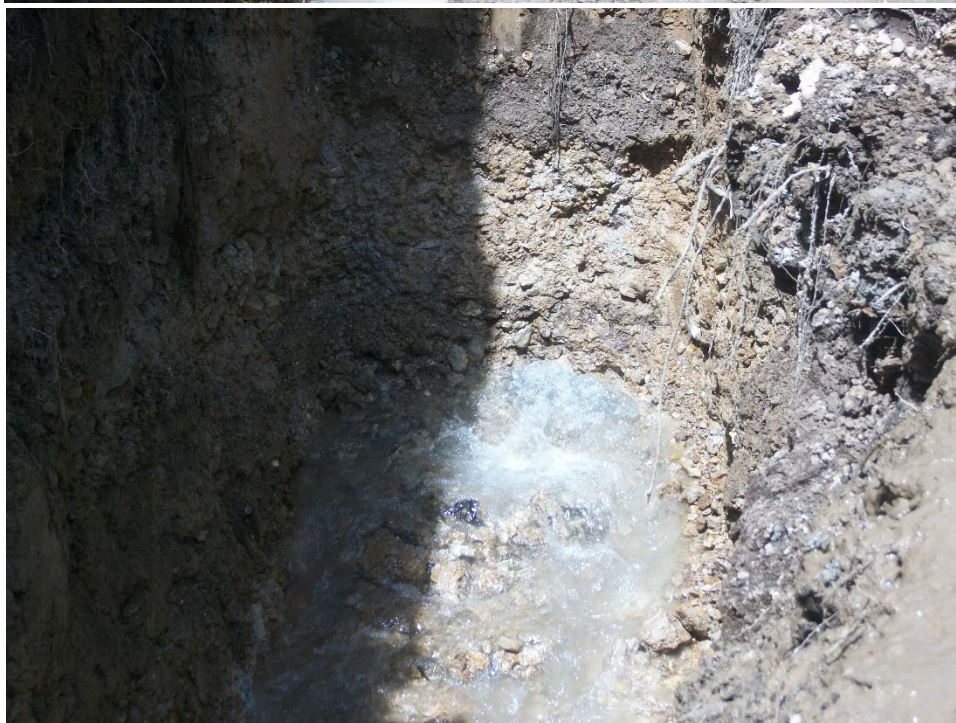
Description: Photo 24
South Trench – High
Inflow, End of Trench

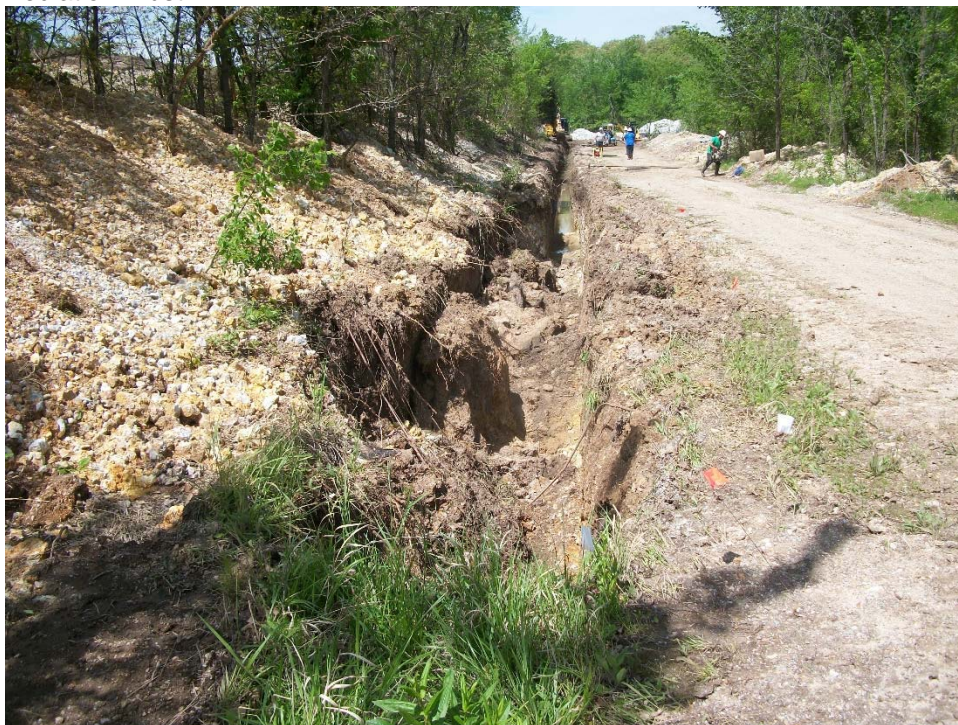
Description: Photo 25
South Trench

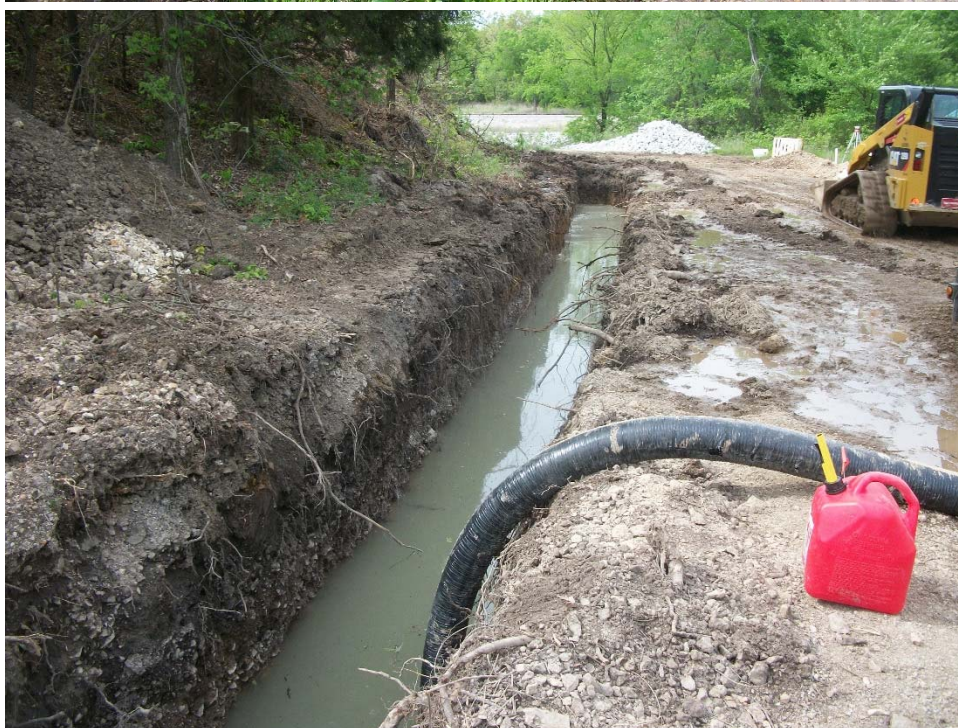
Description: Photo 26
South Trench - Flooded

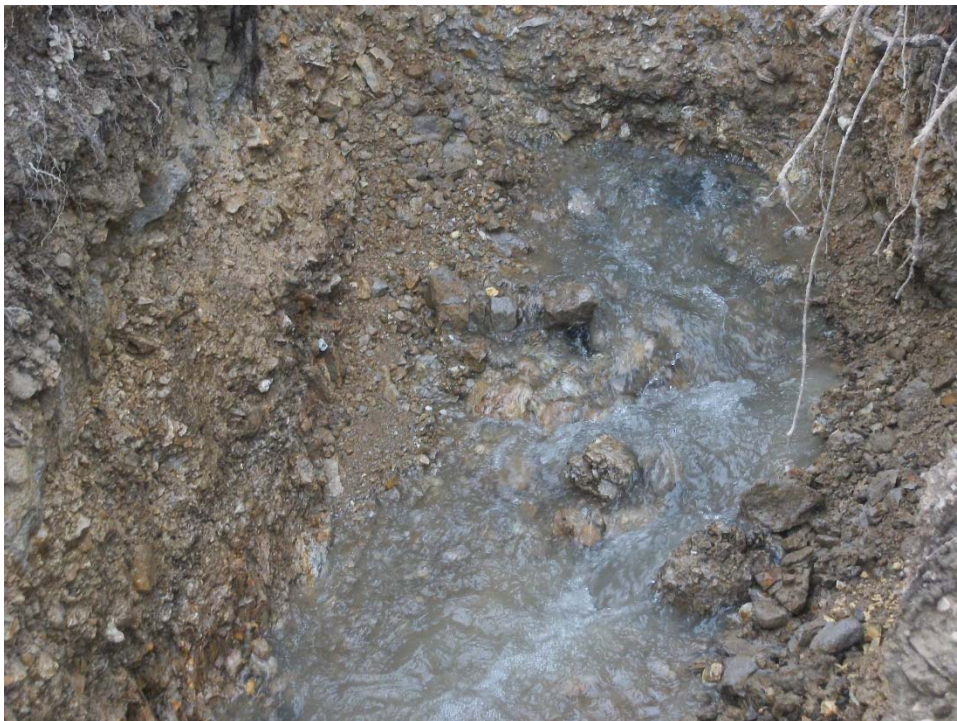
Description: Photo 27
South Trench – High
Inflow

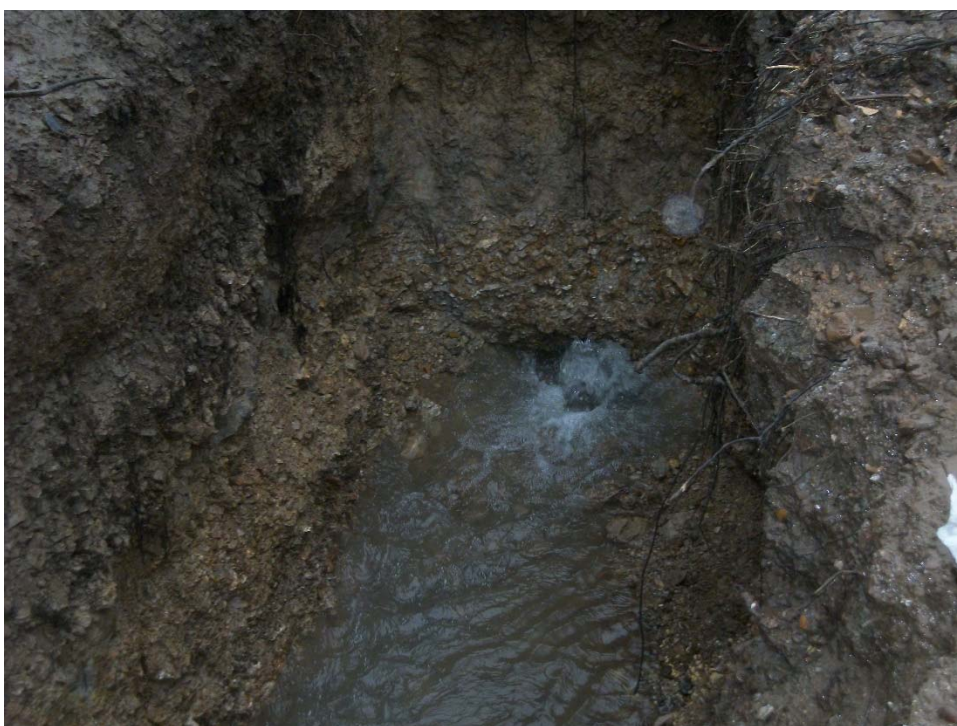
Description: Photo 28
South Trench – High
Inflow

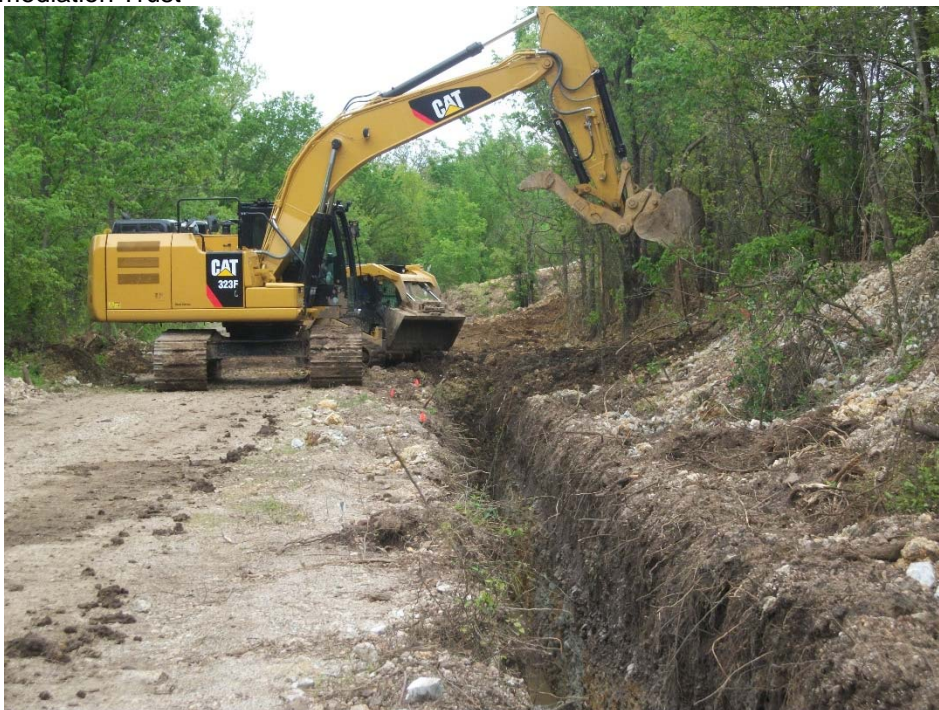
Description: Photo 29
South Trench –
Backfilling

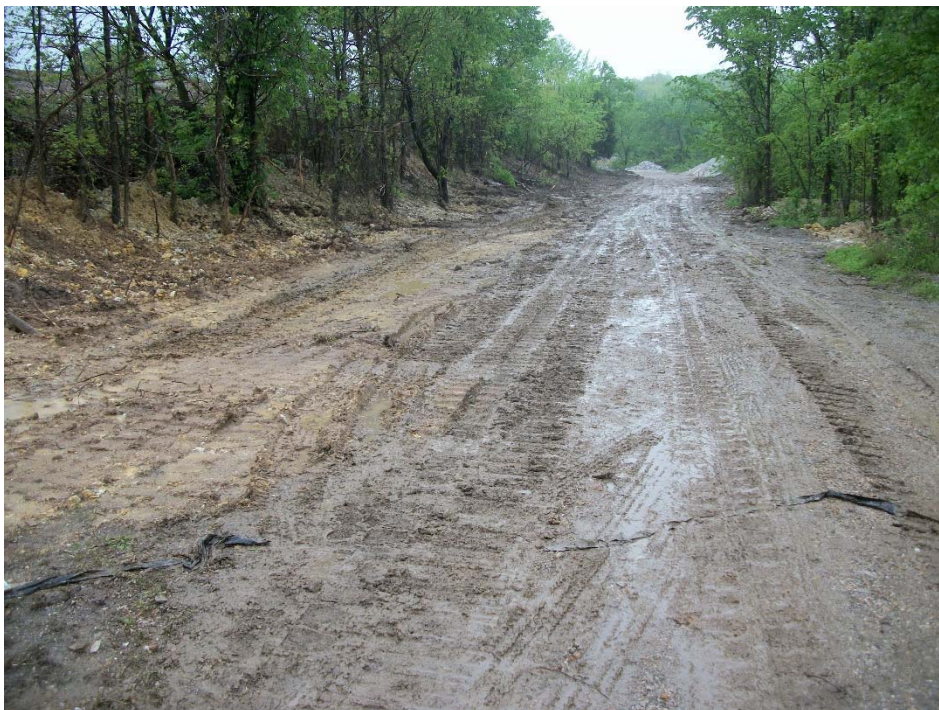
Description: Photo 30
South Trench - Backfilled

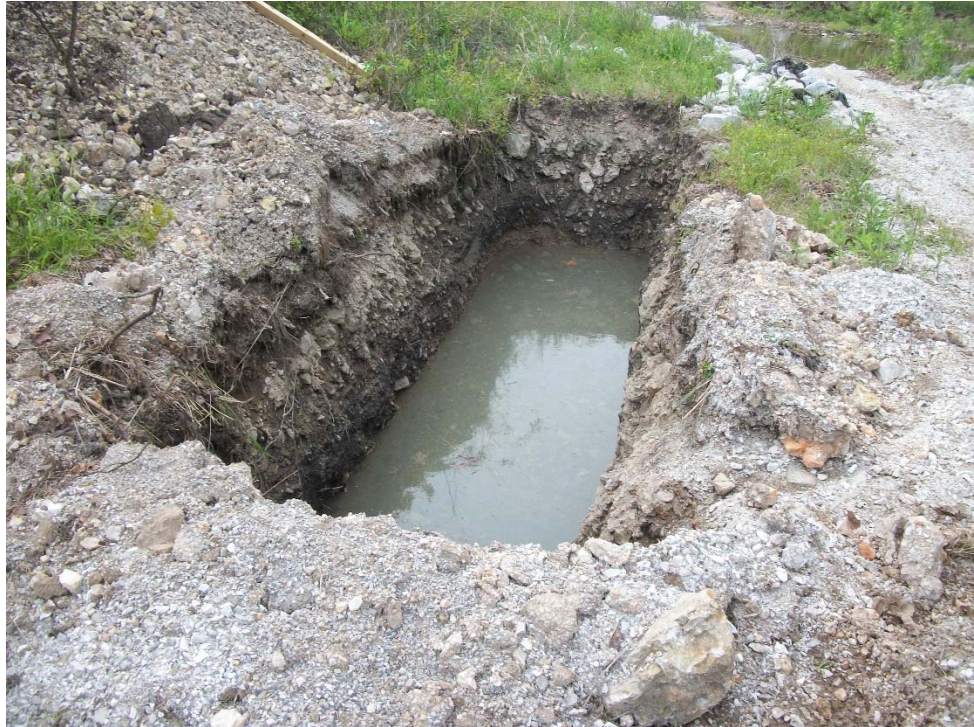
Description: Photo 31
North Trench - Open

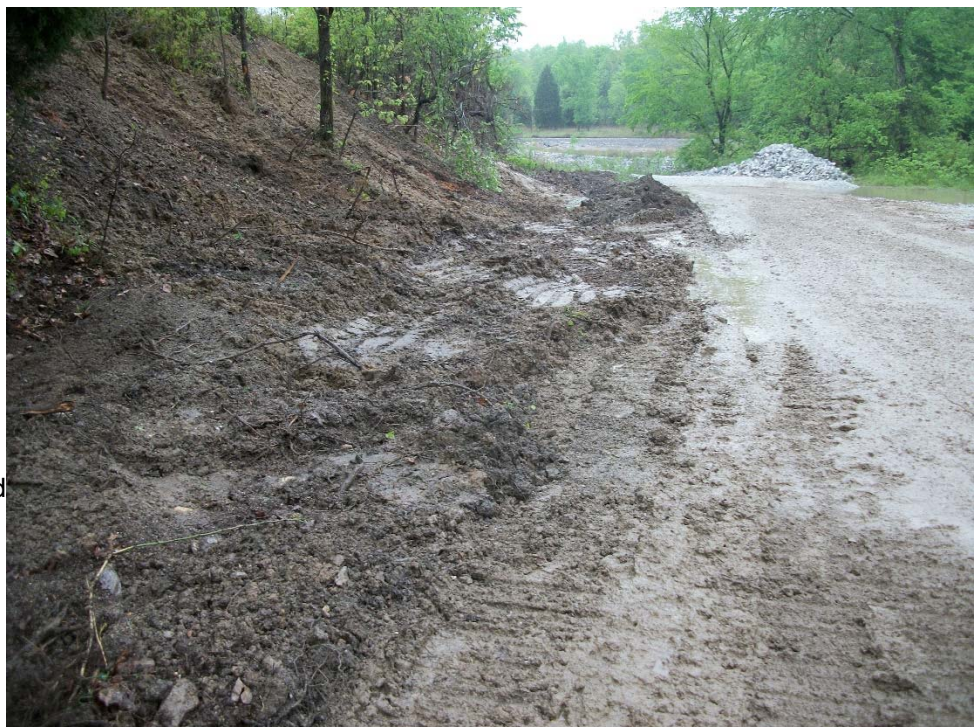
Description: Photo 32
North Trench - Backfilled
